ELFIN COVE BOARDWALK REPAIRS

RECONNAISSANCE REPORT

ELFIN COVE, ALASKA

May 2007

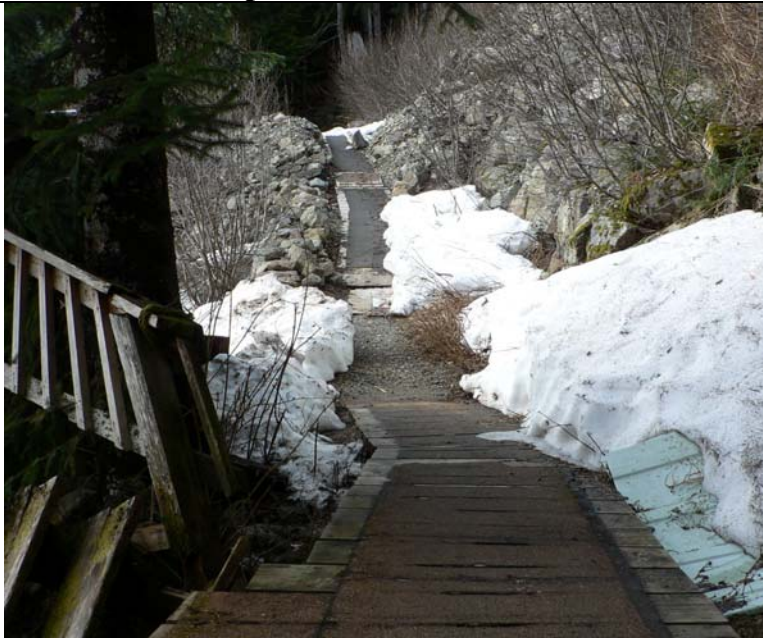
The trail and boardwalk along the 1996 landslide area is frequently covered with running water and rock/gravel washout. The landslide area is still active with loose rocks periodically rolling across or onto the boardwalk. One elderly resident just past the landslide area rides a rascal scooter (power mobility chair) from his house, up this steep boardwalk in order to get to the store and post office. This steep boardwalk and frequent rock debris and water are a hazard to this resident, on his scooter, and all pedestrians. Water running over the boardwalk also washes out the soil around the boardwalk base compromising its stability.

Photo 1 – Steep boardwalk at 1996 landslide area

The boardwalk along this landslide area is at ground level and should be raised to allow drainage and rock debris to pass under the boardwalk. In order to create a more gradual slope, the boardwalk should be raised to a straight line grade from the top of the hill to near the house at B-STA 0+450.

Raising the boardwalk in this area would require a large portion of the project budget. Another option in this area would be to clean the fallen soil and rocks off and around the existing boardwalk and construct a small drainage ditch along the uphill side of the boardwalk. Then raise the boardwalk in one spot just enough to route the drainage ditch underneath the boardwalk. However, this option would not flatten the steep grade of the boardwalk and would require frequent maintenance of the ditch.

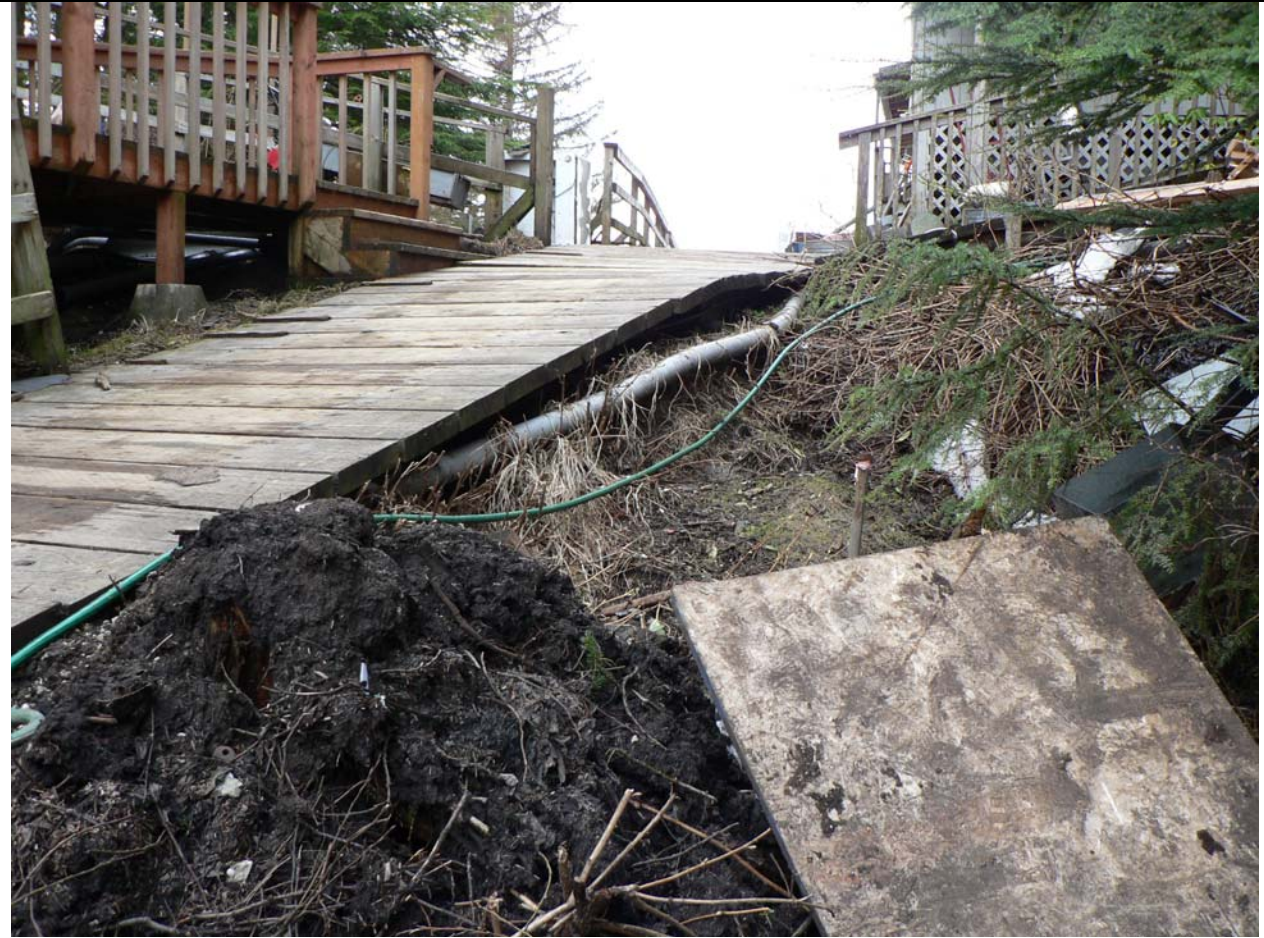
The boardwalk from Coho's Bar and Grill (Coho's), passing in front of the generator shed is steep and has a railing only on one side. Pedestrians have slipped on the boardwalk and fallen off into the swampy area behind the generator building. The steepness of the boardwalk, slick boardwalk surface, and lack of a railing all increase the risk to pedestrians.

Photo 2 – Boardwalk from Coho's

Handrails need to be placed on both sides of the boardwalk from Coho's entrance down to the school house building. This will provide additional stability to pedestrians walking this section of the boardwalk and also keep them from falling off.

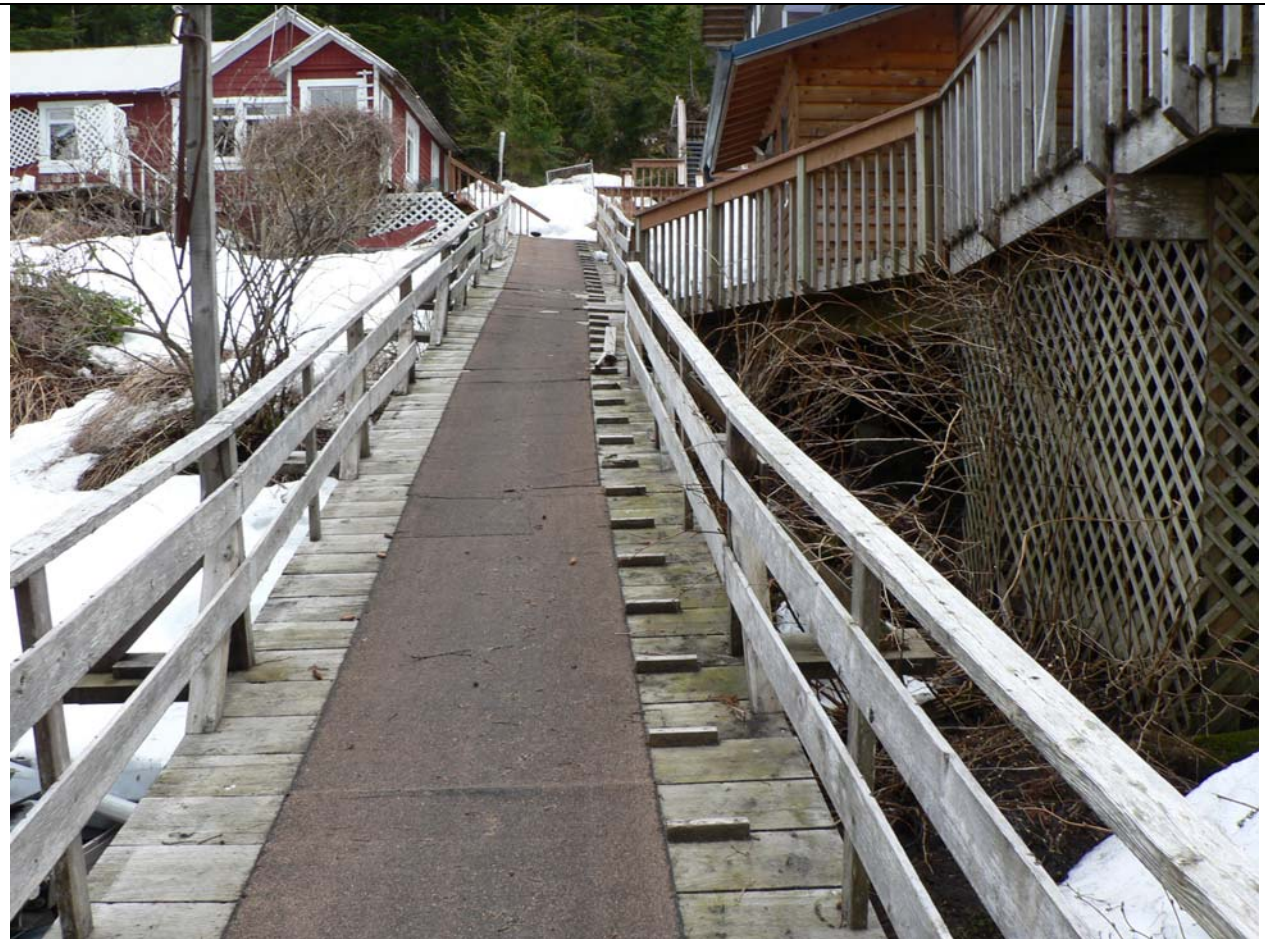
Several foundations under the boardwalk on Lot 4A have sunk 6 to 12 inches. Running water has eroded some foundations, while others have sunken into the soft soils. This has caused the boardwalk to tilt sideways and twist creating a hazardous walking surface. Movement of the boardwalk is putting stress on the utilities attached to the boardwalk, increasing the risk of utility outage.

Photo 3 – Boardwalk on Lot 4 A has twisted and tilted

The boardwalk along this section should be jacked up and leveled. New foundations should be constructed that extend through the top soft soils. New posts and braces will then need to be constructed on the new foundations. Handrails along this section were not replaced in 2000, much of the handrail headers are weak or broken and should be replaced.

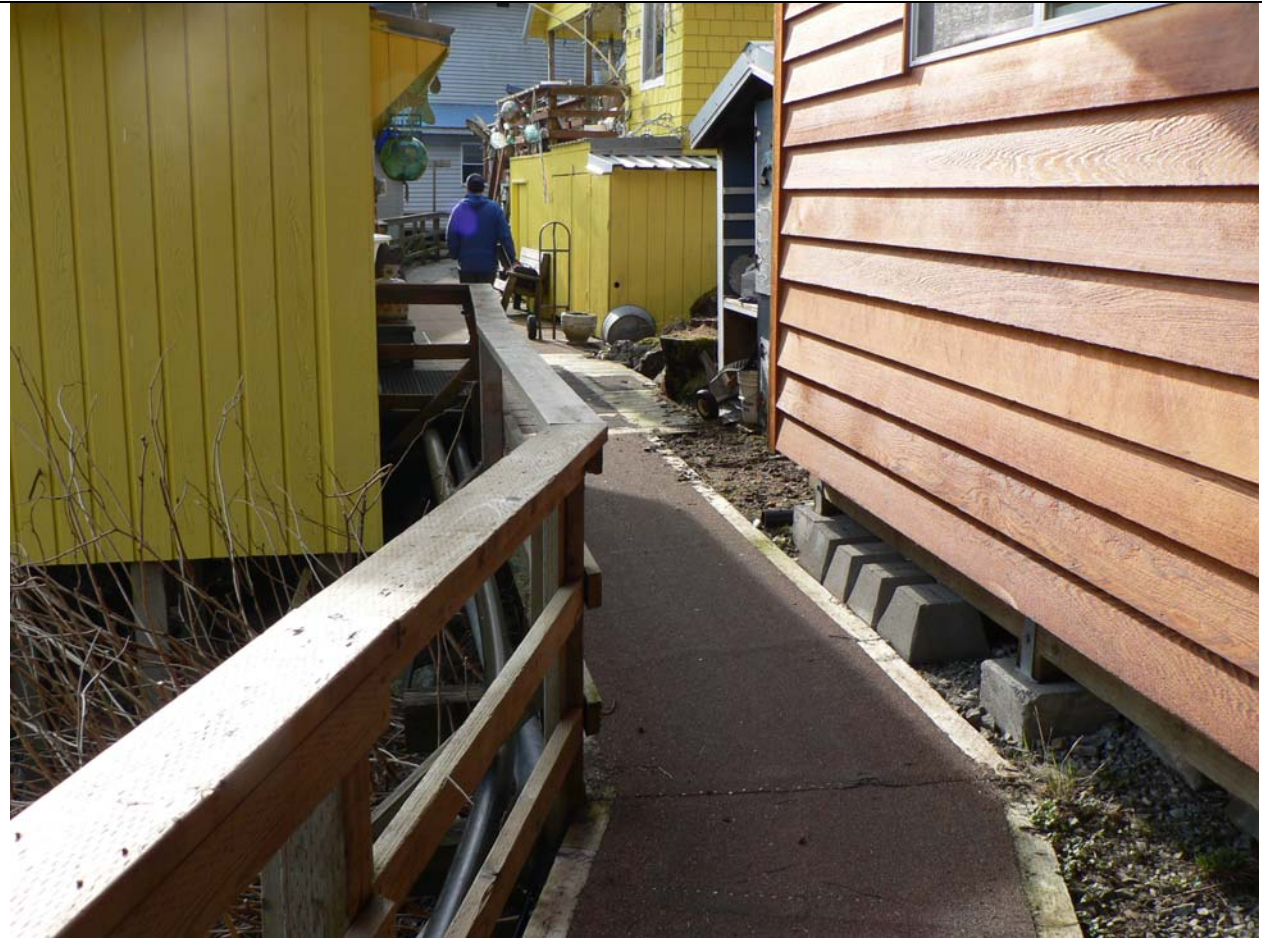
The boardwalk passes through a narrow spot between two houses near B-Station 0+030. Most of the boardwalk up to this area is about 60 inches wide. The boardwalk narrows down to 42 inches between the houses. Although meeting the minimum 36-inch width requirement for a wheelchair, it makes hauling freight through this area more difficult and would prohibit wheelchairs to pass each other at this location.

Photo 4 – Narrow walk at B-STA 0+030

Neither the Community Council nor the DOT&PF has identified widening the boardwalk at this location as a safety concern. Widening the sidewalk in this area would require a considerable work because the water line and power line would have to be relocated.

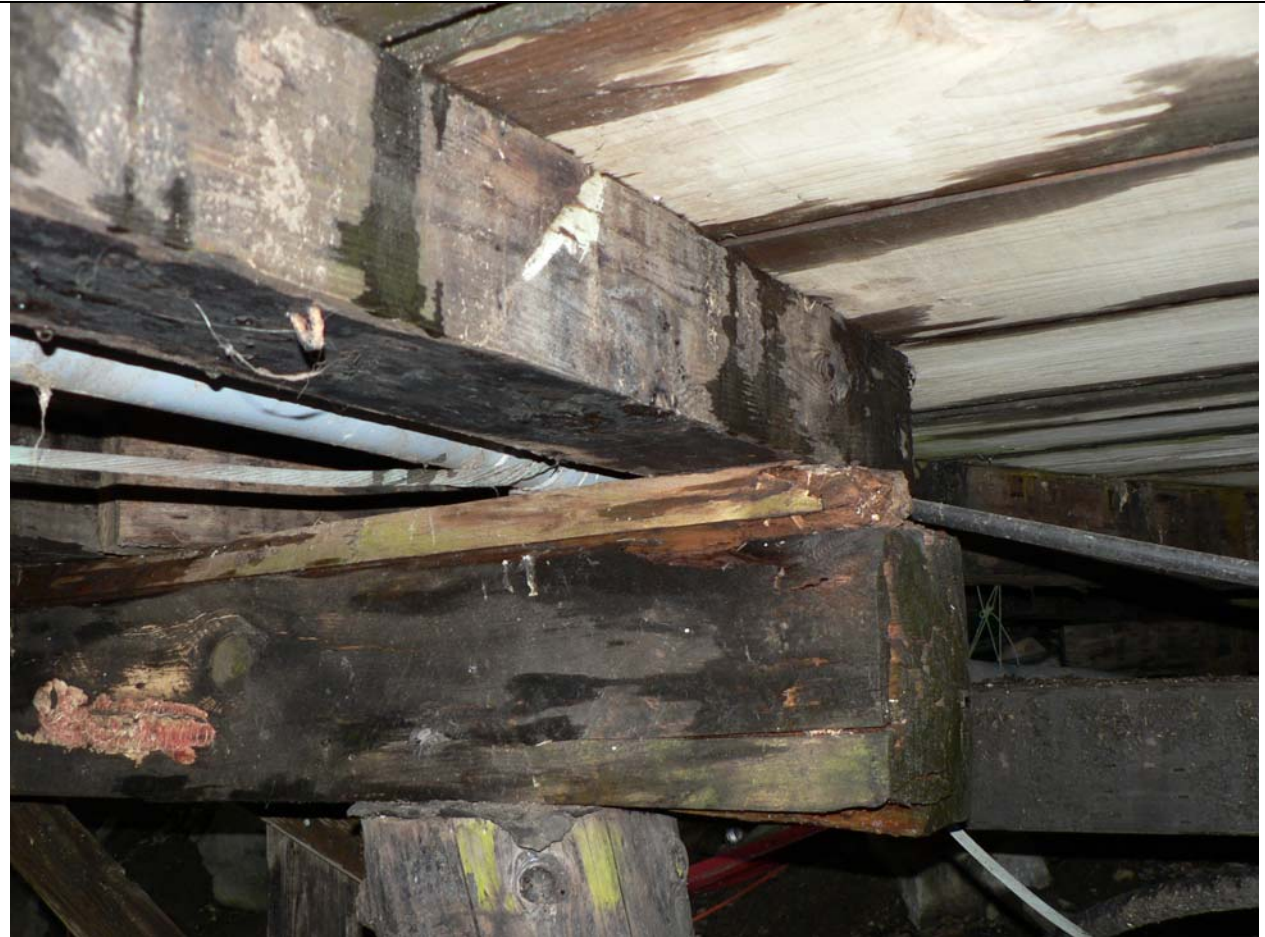
Inspecting every structural member of the boardwalk is beyond the scope of this report. DOT&PF replaced many rotten sections of boardwalk in 2000 and in 2007 it still appears to be in fairly good shape structurally. However, a few areas of deterioration were observed during the site visit. Some spots include B-STA 0+000 where one set of posts and headers are deteriorating.

Photo 5 – B-STA 0+000 Post and headers are deteriorating

Future improvements should include a contingency item for inspecting all structural members and replacing miscellaneous rotten structural members as directed by the on-site engineer or inspector.

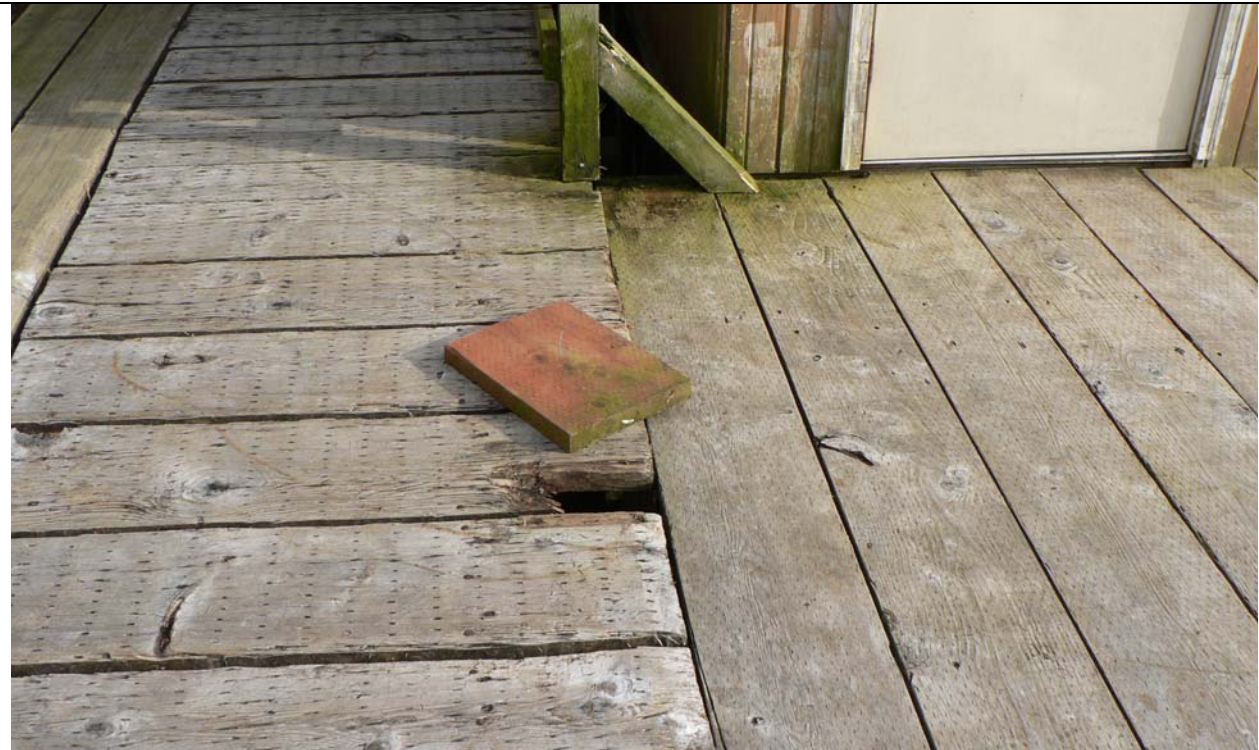
Photo 6 – A-STA 0+310

At A-STA 0+310 a chunk of the boardwalk planking has broken out leaving a hole.

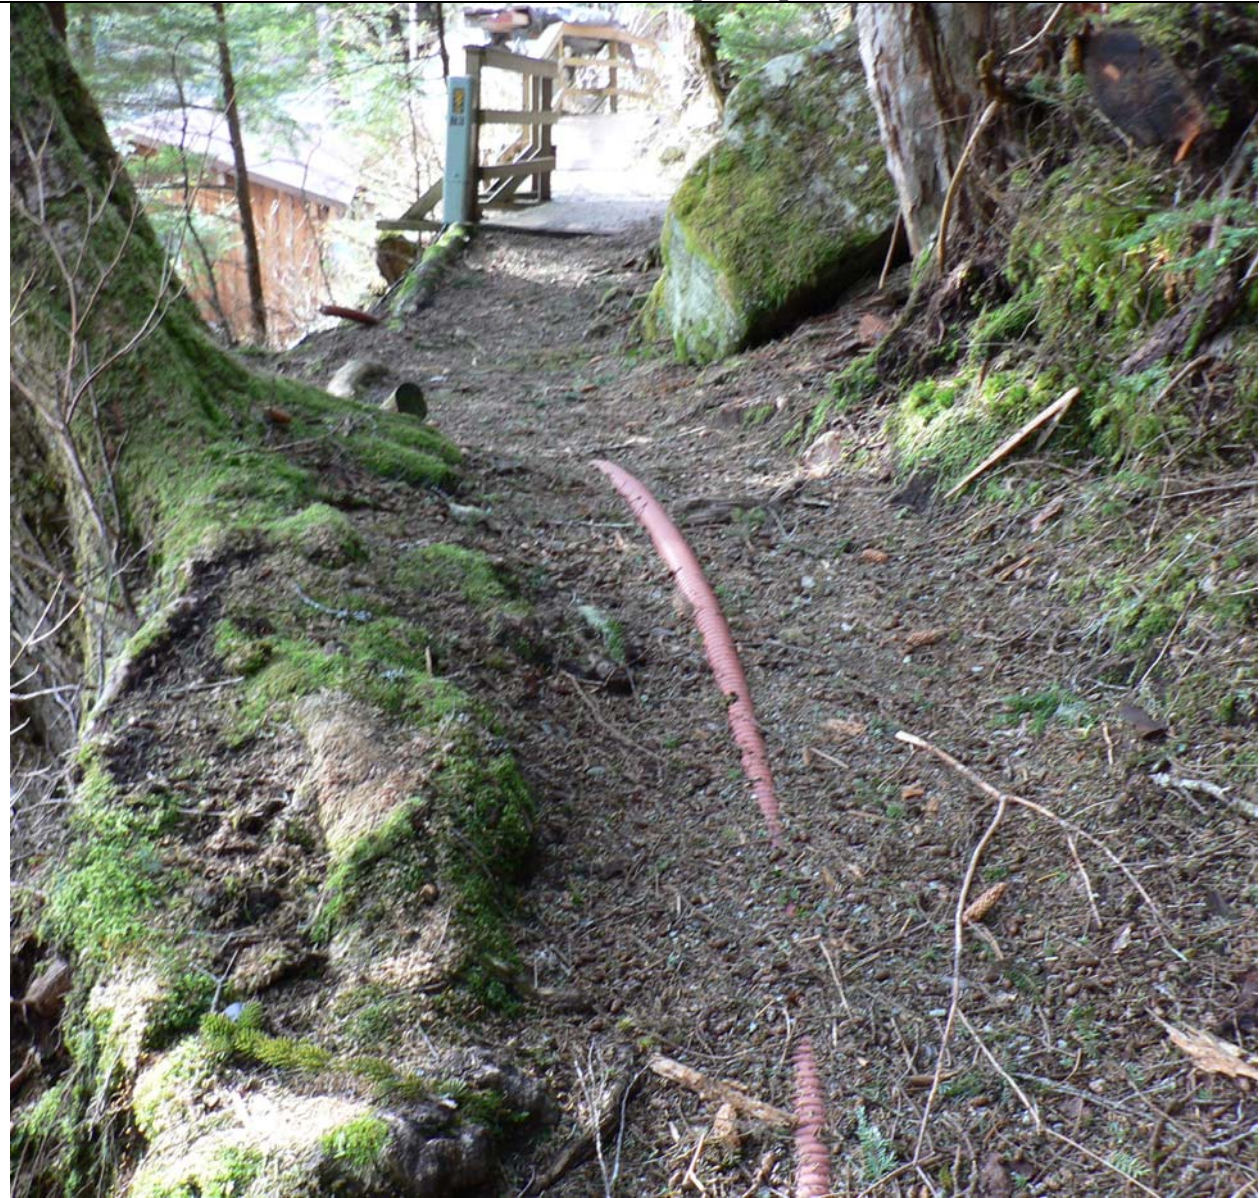
The power cable runs alongside or underneath the boardwalk. The cable is not covered at B-STA 0+360

Photo 7 – B-STA 0+360 Exposed power cable

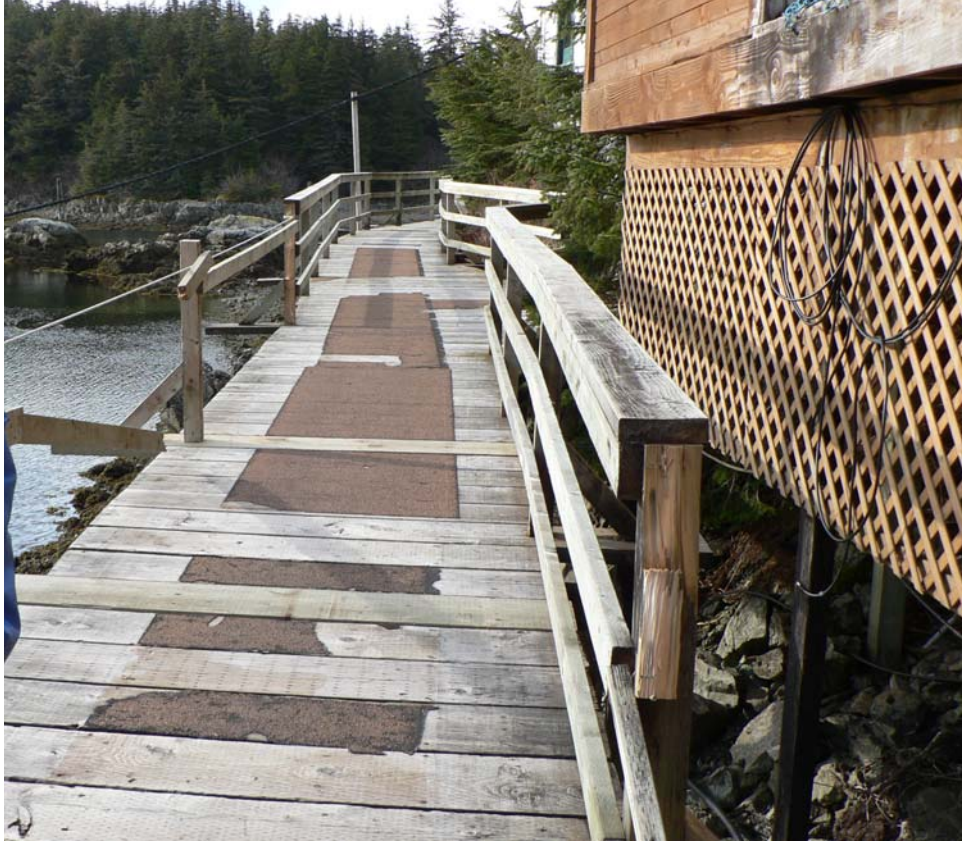
Elfin Cove received almost 300 inches of snow this winter. This heavy snow and ice falling off buildings has damaged many handrails. Locations of damaged handrails include:

Photo 8 – Damaged handrail at A-STA 0+330

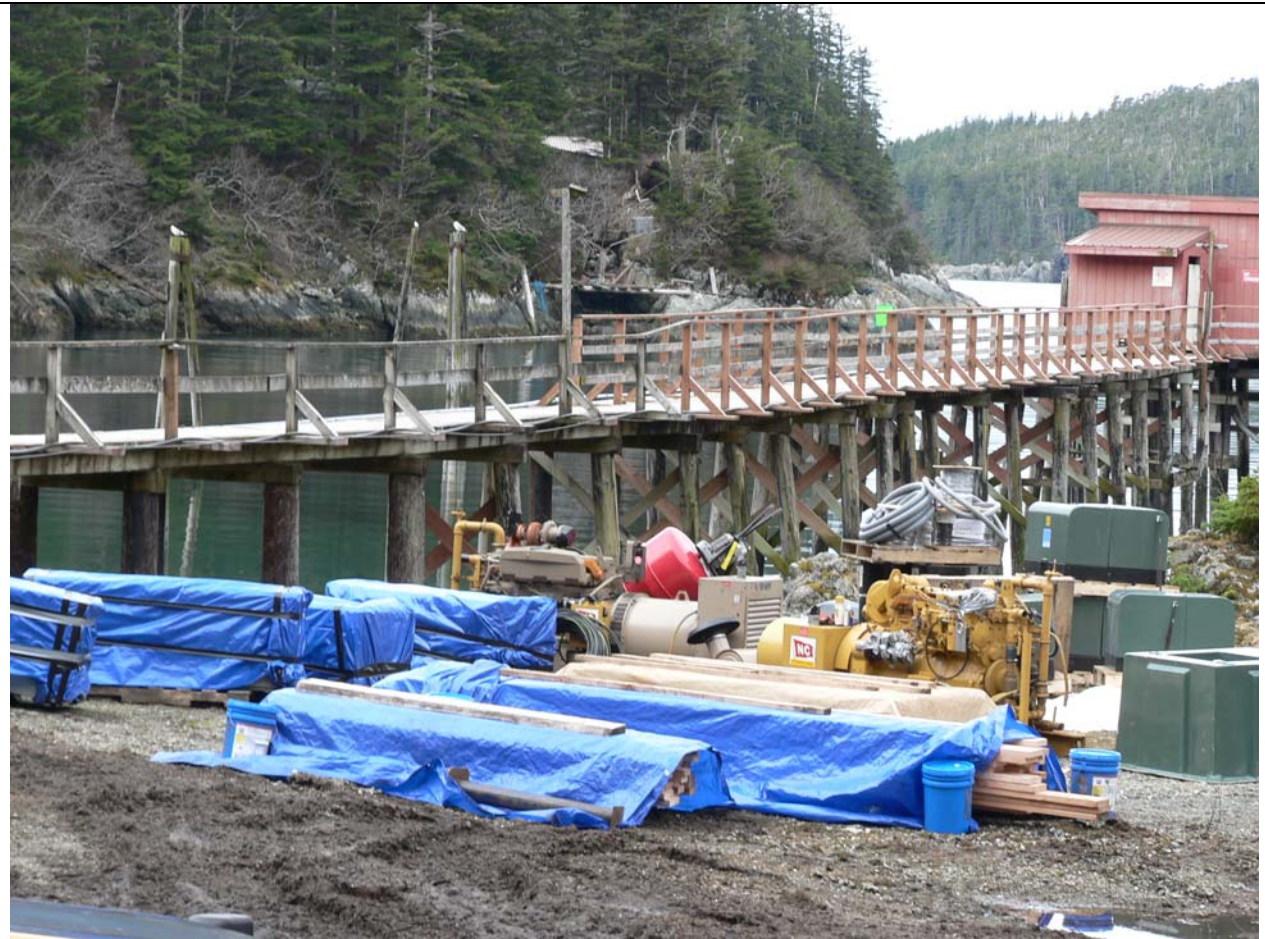
The decking and handrails along the fuel dock boardwalk are deteriorating creating the risk of deck planks crushing under a load and handrails breaking off when used by pedestrians. The fuel dock height varies from a couple of feet off the ground to over 8 feet. Someone falling off the fuel dock ramp could be seriously injured. This boardwalk decking and handrails need to be replaced now. The boardwalk is founded on 12- to 18-inch diameter treated wood piles that appear to be in fair condition. There seems to be some uncertainty on if the state owns the fuel dock boardwalk.

Photo 9 – Fuel Dock

The decking and handrails along the fuel dock boardwalk should be replaced from the connection with the A-Boardwalk out to where the handrail was reconstructed a couple years ago.

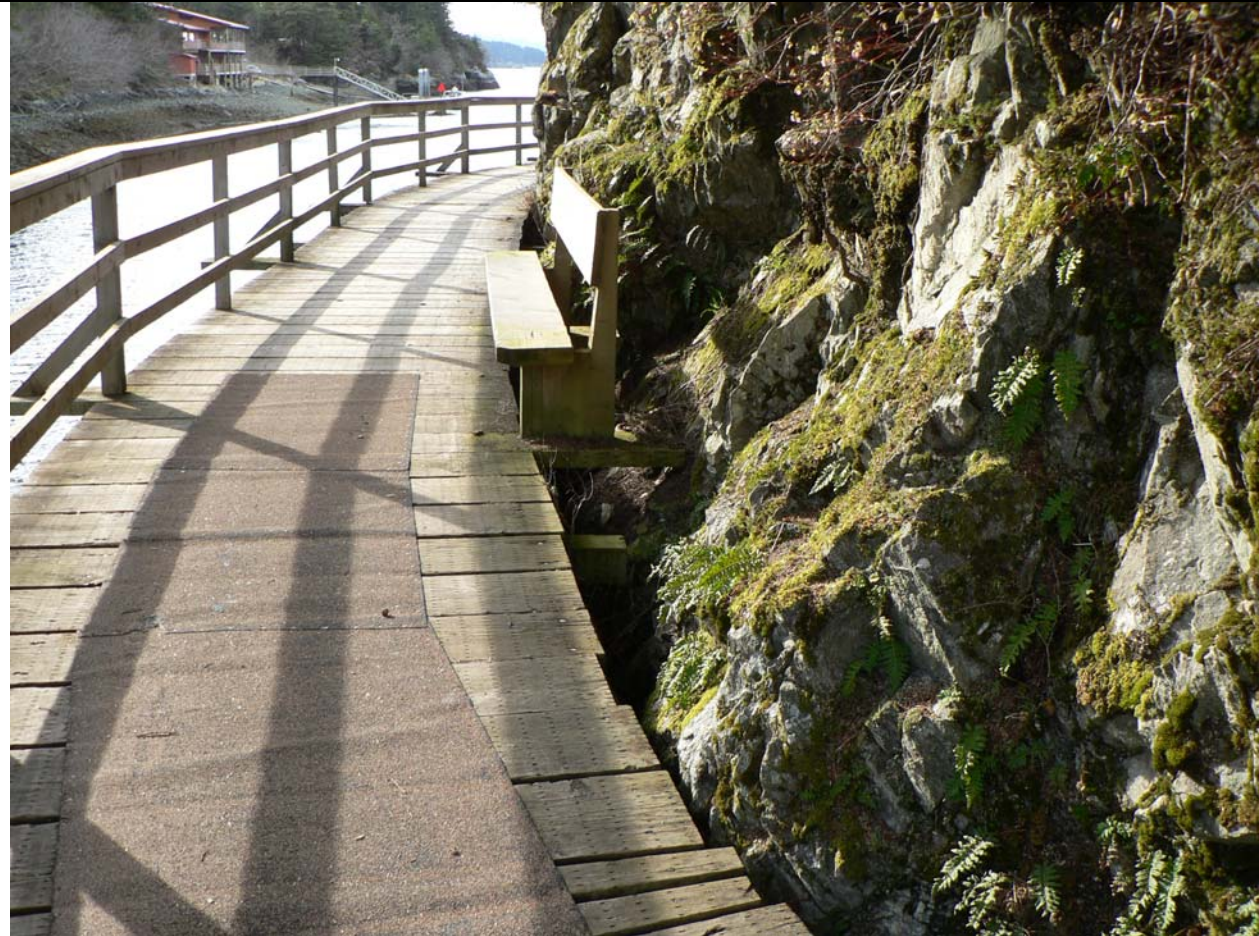
Elfin Cove boardwalks currently use asphalt roofing rolls to provide a slip resistant surfacing. This surfacing has the lowest initial cost and is relatively easy to install and replace. However, this surfacing typically lasts about one season and only a half season in high traffic areas. Asphalt roofing rolls are currently installed in one strip down the center of the boardwalk. This leaves a strip of wood boardwalk on each side of the asphalt roofing roll creating an non-uniform and slippery walking surface.

Photo 10 – Asphalt roofing rolls
